EAST RENFREWSHIRE COUNCILCABINET2 March 2017Report by Director of EnvironmentEASTWOOD NURSERY ALLOTMENTS ASSOCIATION**PURPOSE OF REPORT**

**EASTWOOD PARK ALLOTMENT GARDENS**  
**REPORT ON STRUCTURAL INSPECTION OF NORTH BOUNDARY WALL**

East Renfrewshire Council  
Property and Technical Services  
2 Spiersbridge Way,  
Thornliebank,  
G46 8NG

Charles Scott & Partners  
Venlaw Building  
349 Bath Street  
GLASGOW G2 4AA

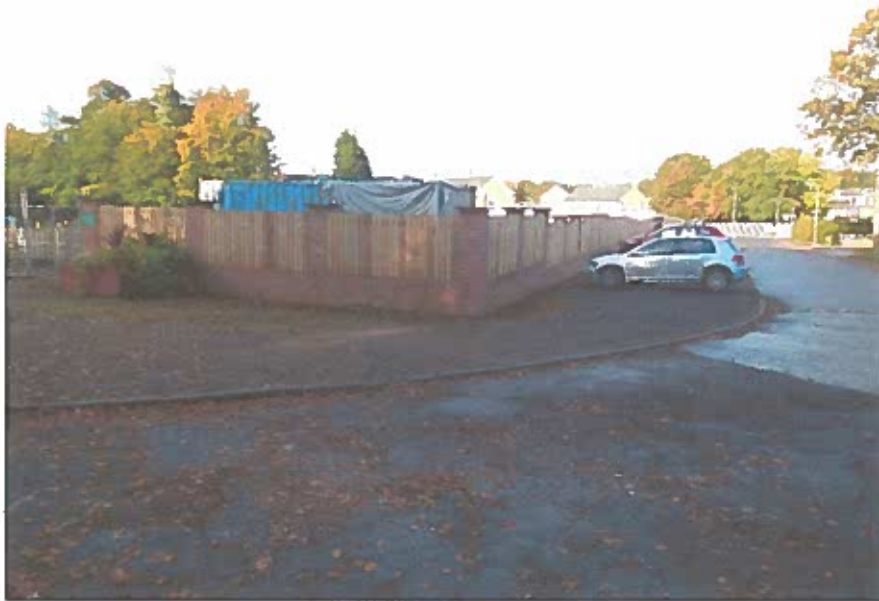
Appendix A  
Photograph 1

View Looking East onto Wall

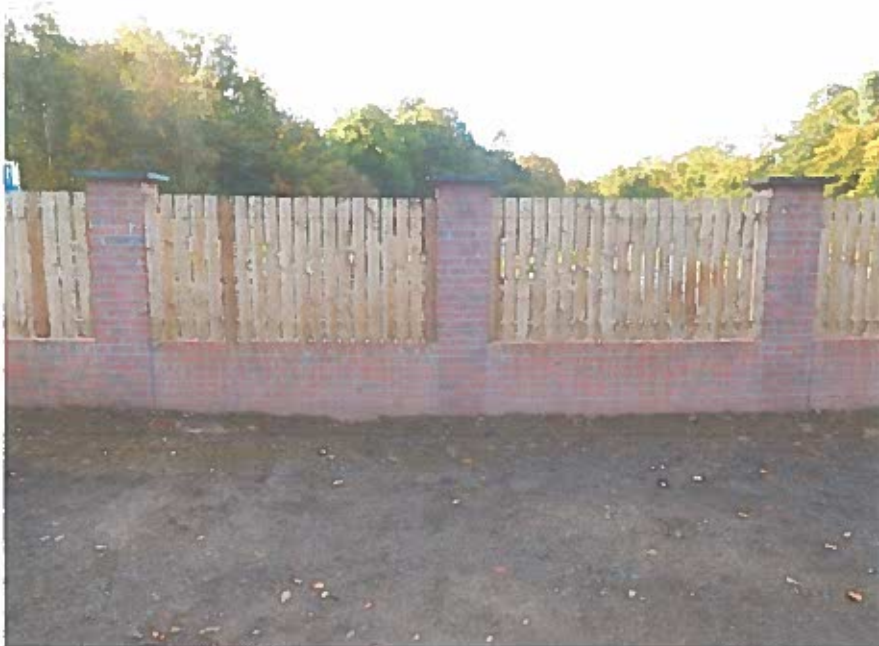
Photograph 2

View on Outside Face of Wall Showing Nature of Construction

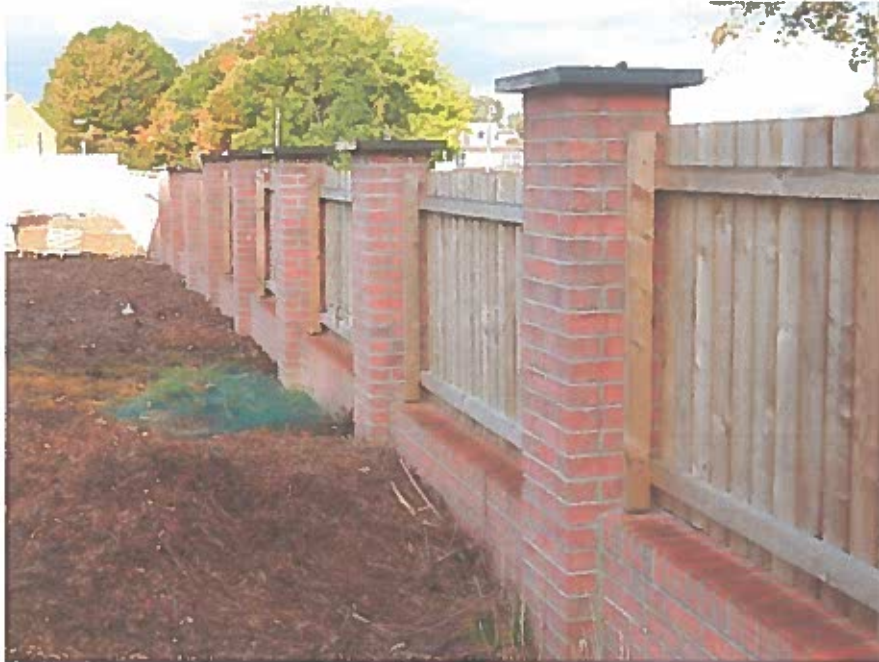
Photograph 3

View on Inside Face of Wall Showing Nature of Construction

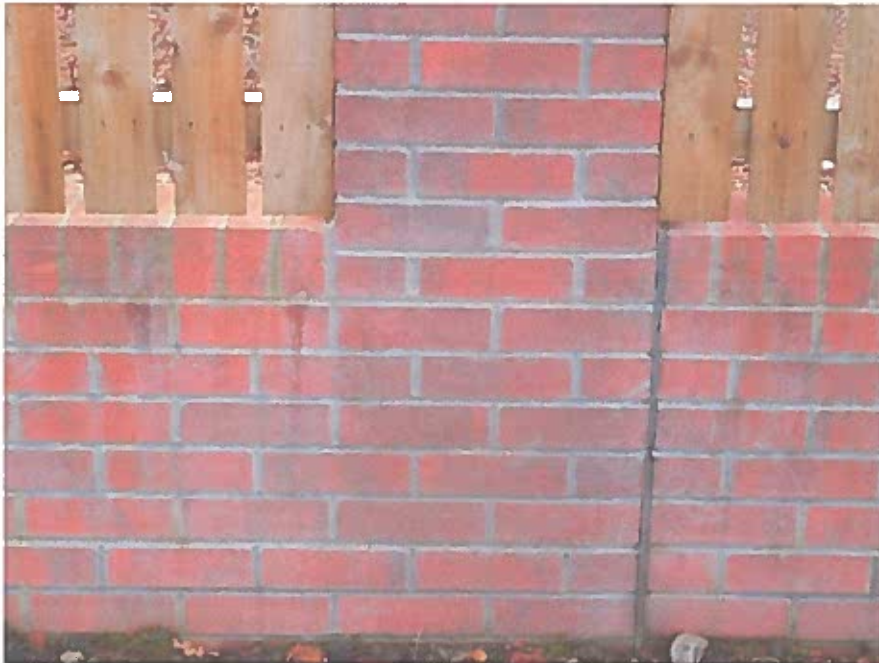
Photograph 4

The brickwork piers and dado walls appear to have been well constructed. We found the wall to be acceptably plumb and plane with no sign of any significant structural movement having occurred since the wall was built. There has been a slight opening up of a number of the brick movement joints. In some instances, the sealant material has become loose and is hanging out to expose the foam joint filler.

Typical Movement Joint. Slight Opening of Joint with Loose Sealant Evident

Based on our visual observations and experienced judgement, we consider that the brick pier and dado wall structure is safe from a structural perspective. If a definitive statement is required in that regard, we would have to carry out appropriate calculations, albeit we feel that would be unnecessary in this instance. A review of the movement joints sealant material should be carried out to identify a suitable alternative that will be able to accommodate seasonal thermal movement without failure.

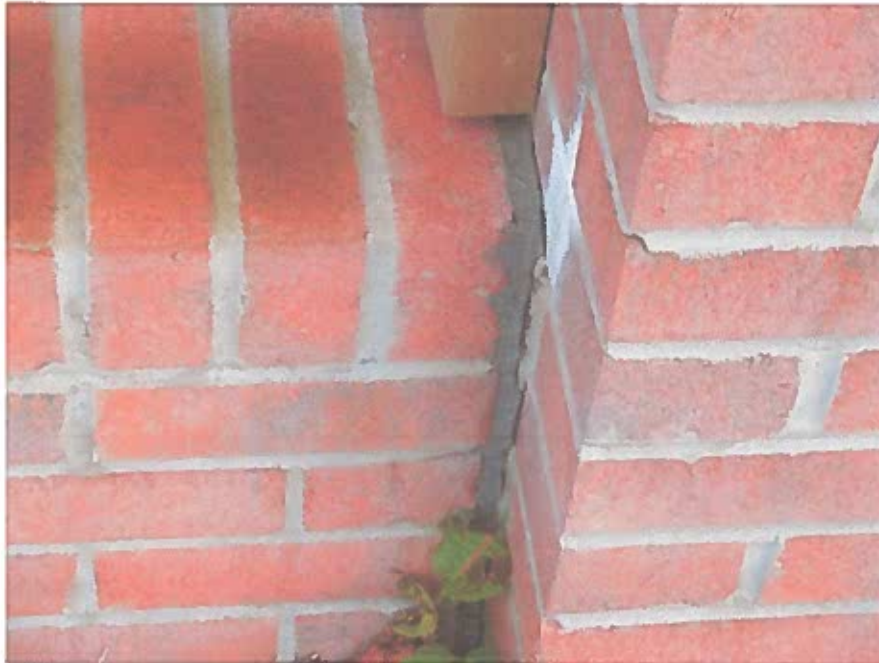
Photograph 5

Internal View of Typical Movement Joint

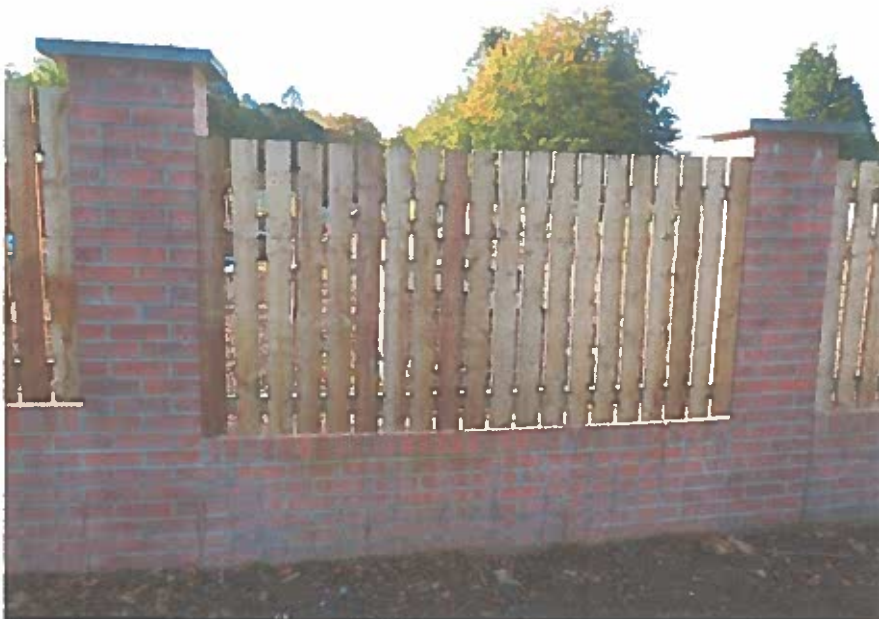
Photograph 6

We do have some concerns regarding the overall structural integrity of the timber panel construction and its restraint back to the brick piers. We have some doubt that the two horizontal rails that support the timber boards may not have adequate strength under design wind loading. The vertical timber battens that provide a backing to support the horizontal rails appear to have only 2 fixings into the brickwork. Whilst these fixings appear to be generally appropriately located close to the position of the end of the horizontal rails, we think it appropriate that further fixings should be introduced. Further, from a visual only inspection we cannot establish how these vertical battens are fixed to the horizontal rails. With regard to the nature and construction arrangement of the timber infill panels we would recommend that details of the fixing arrangements should be obtained and a design check carried out accordingly to establish whether any enhancement is appropriate and, if so to enable specification of appropriate measures.

Outside View of Timber Infill Panel

Using engineering judgement based on our visual inspection, it is our considered opinion that the brick work elements of the north boundary wall and east return wall of Eastwood Park Allotments are in a safe structural condition. We recommend, however that further investigation is carried out with regard to the design and installation of the timber infill panels to ensure that these can adequately sustain design wind loads.
